**DEPARTMENT OF TRANSPORTATION**

Contract #: 04-0120F4Cty: SF/ALA Rte: 80 PM: 13.2/13.9File #: 69.28**WELDING INSPECTION REPORT****Resident Engineer:**Siegenthaler, Peter**Address:** 333 Burma Road**City:** Oakland, CA 94607**Report No:** WIR-019647**Date Inspected:** 29-Dec-2010**Project Name:** SAS Superstructure**OSM Arrival Time:** 700**Prime Contractor:** American Bridge/Fluor Enterprises, a JV**OSM Departure Time:** 1900**Contractor:** Zhenhua Port Machinery Company, Ltd (ZPMC), Changxing Island **Location:** Shanghai, China**CWI Name:** Mr. Liu Fa Wen**CWI Present:** Yes No**Inspected CWI report:** Yes No N/A**Rod Oven in Use:** Yes No N/A**Electrode to specification:** Yes No N/A**Weld Procedures Followed:** Yes No N/A**Qualified Welders:** Yes No N/A**Verified Joint Fit-up:** Yes No N/A**Approved Drawings:** Yes No N/A**Approved WPS:** Yes No N/A**Delayed / Cancelled:** Yes No N/A**Bridge No:** 34-0006**Component:** OBG**Summary of Items Observed:**

## WELDING INSPECTION REPORT

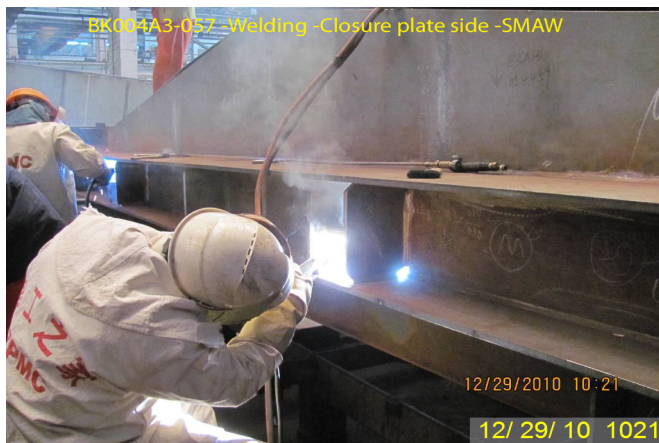
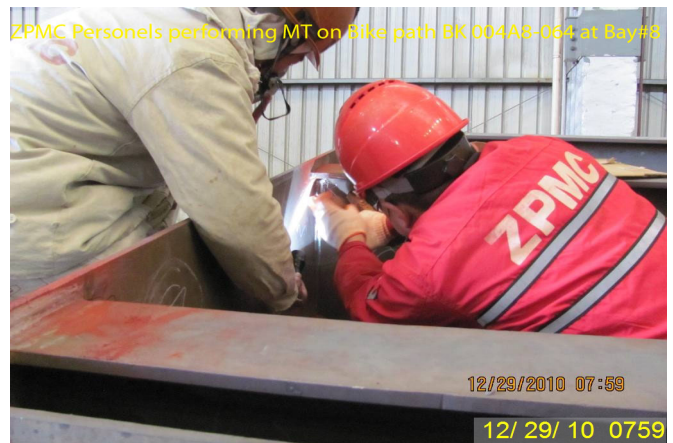
This QA inspector performed Visual Inspection (VT) of 100% of the area previously tested and accepted by ZPMC Quality Control personnel. The member is identified as Bike path closure plates at both ends. The weld designations reviewed are as follows:

BK004A -057

Unless otherwise noted, all work observed on this date appeared to be in general compliance with the applicable contract documents.
